Ground Penetrating Radar Report

City of Largeville

Parkade P5

Re: Concrete Floor Inspection using GPR Technology
Parkade P5
Largeville, Alberta
February 27, 2019

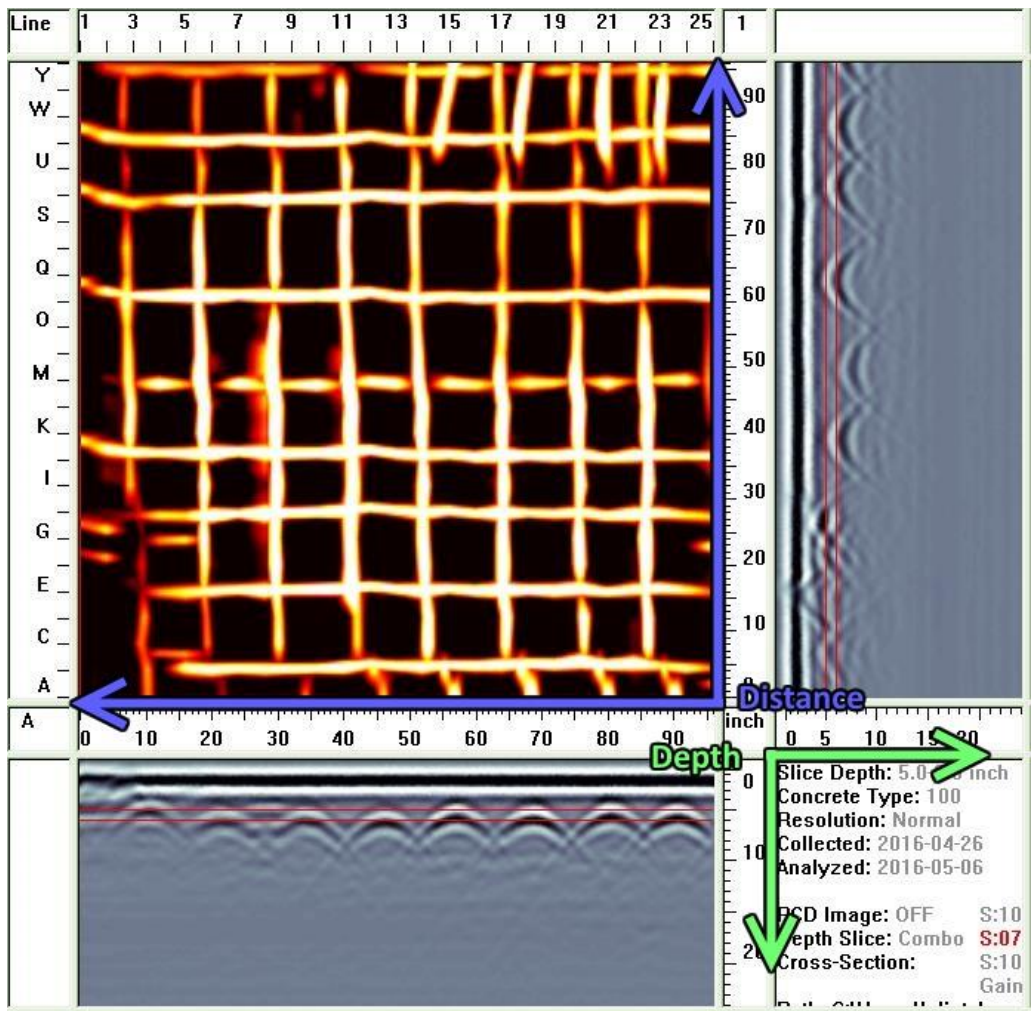
The top of the re-bar can be seen in the Side View Scan portion as the top of the white Hyperbola. The **depth** is measured in inches up and down the side of the Hyperbola (up to 18 inches). The **distance** is shown along the top of the hyperbolas (up to 96 inches). These positions correspond to the red crosshairs on the Plan View Map.

The re-bar pattern can be seen in the Plan View Map, as the depth increases in each image the lower signals can be seen coming more into view, with the upper level disappearing. The information shown in the Plan View Map is relevant only to the depth indicated and shown between the 2 red lines in the Side View Scan.

The GPR Image below is an image at a depth slice of 5 to 6 inches. (8' x 8' Grid size).

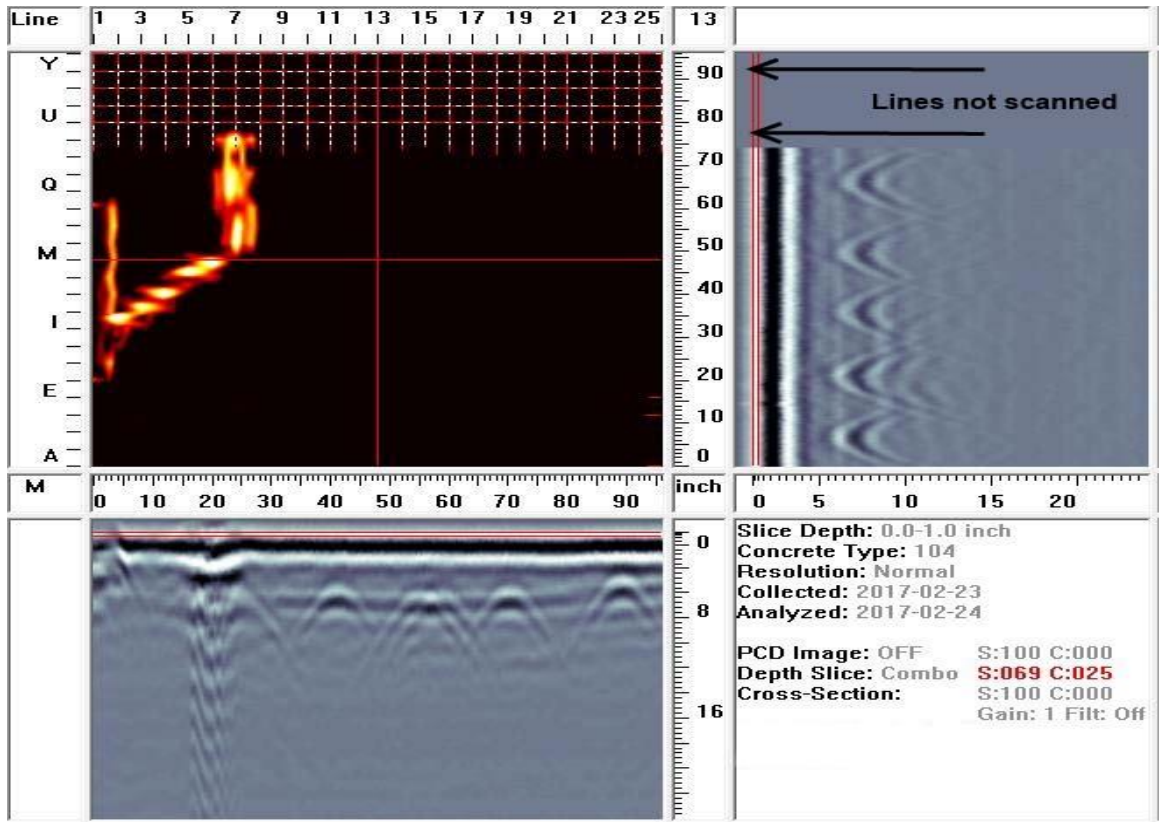
The picture below shows an example of what the scan lines look like if they were not scanned. This may be caused by a track or wall obstruction, or the inspection area did not require a full scan.

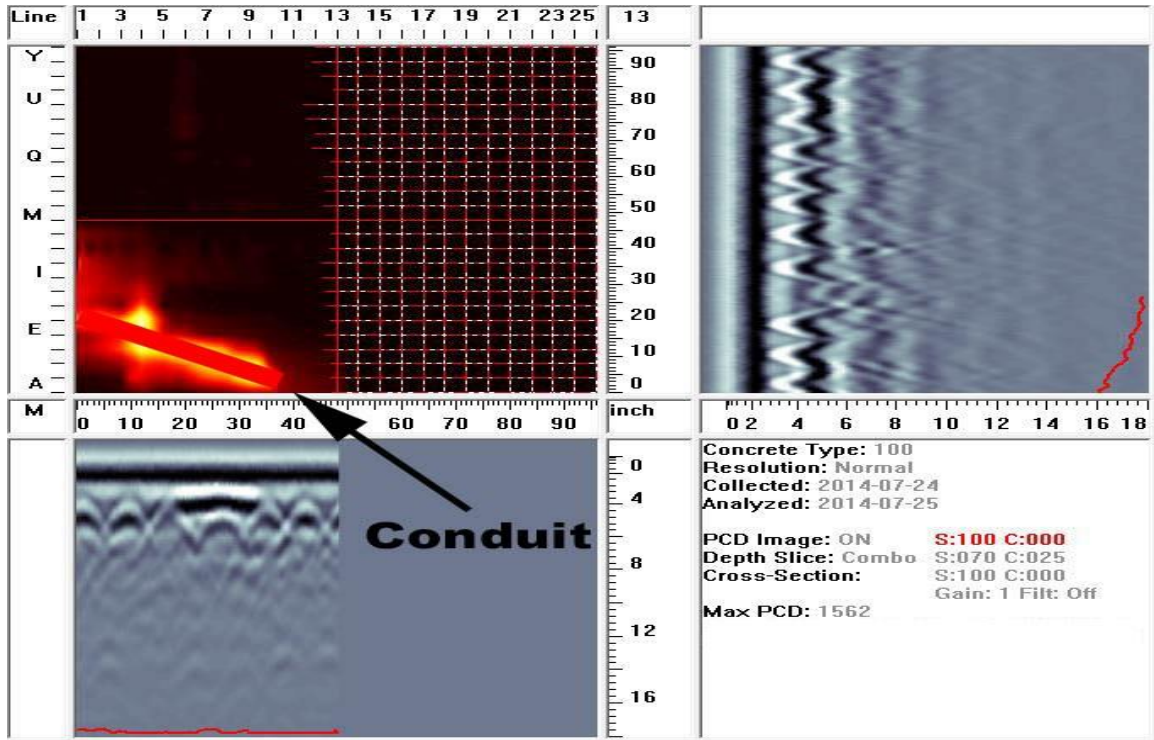
The GPR Image below is an example picture of power for an electrical line. The top picture shows the electro-magnetic detector feature turned on and labelled.

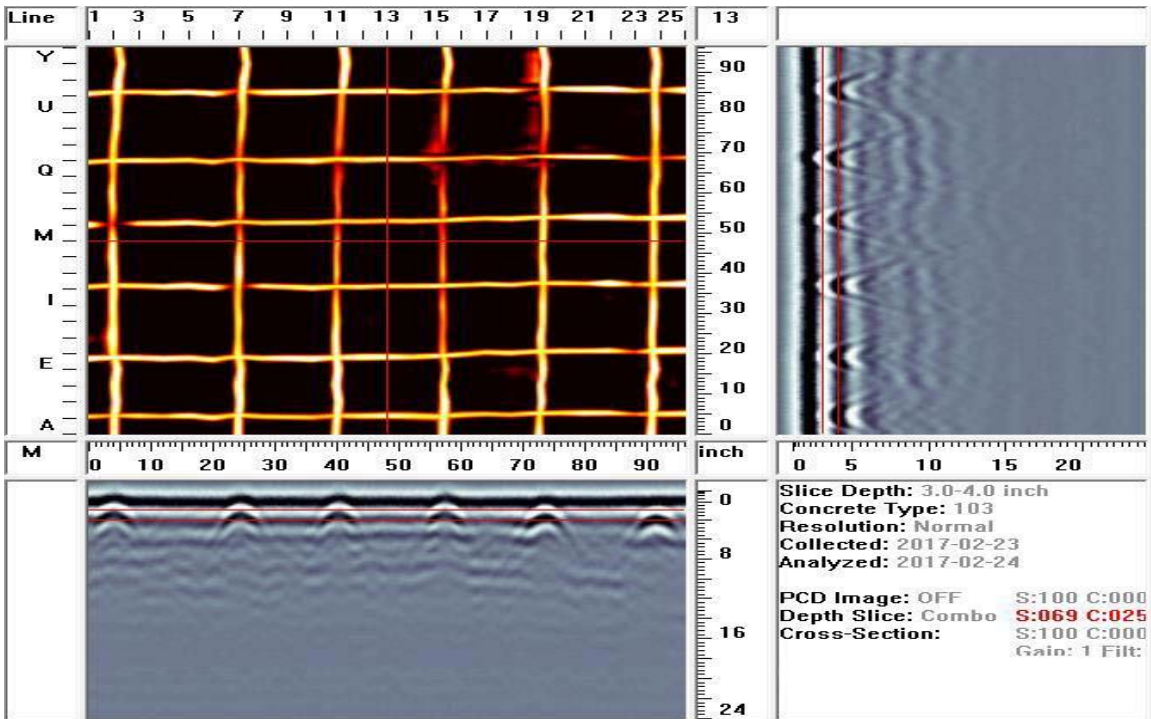
The GPR Image below is an Image at a depth slice of 3 inches. This is showing an example of what the rebar signals will look like. The rebar signals can be seen in the plan view map and have been labelled with blue lines. The side view scans have also been labeled showing some of the related GPR signals

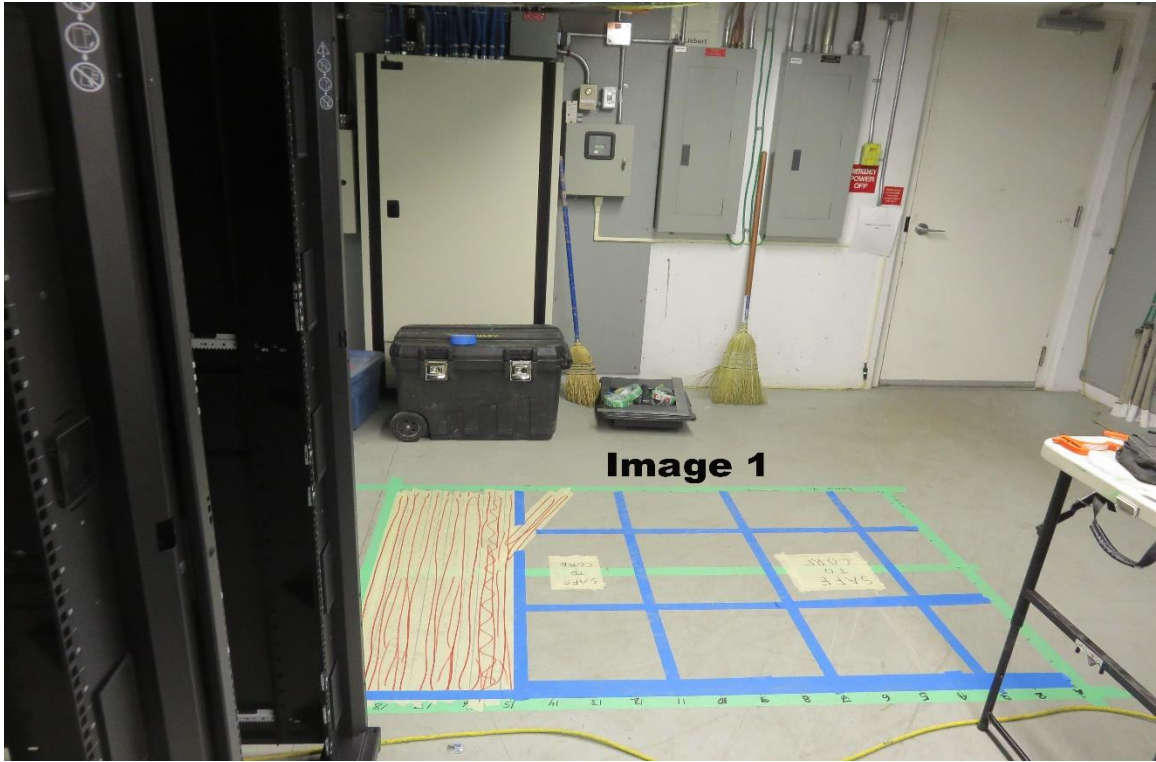
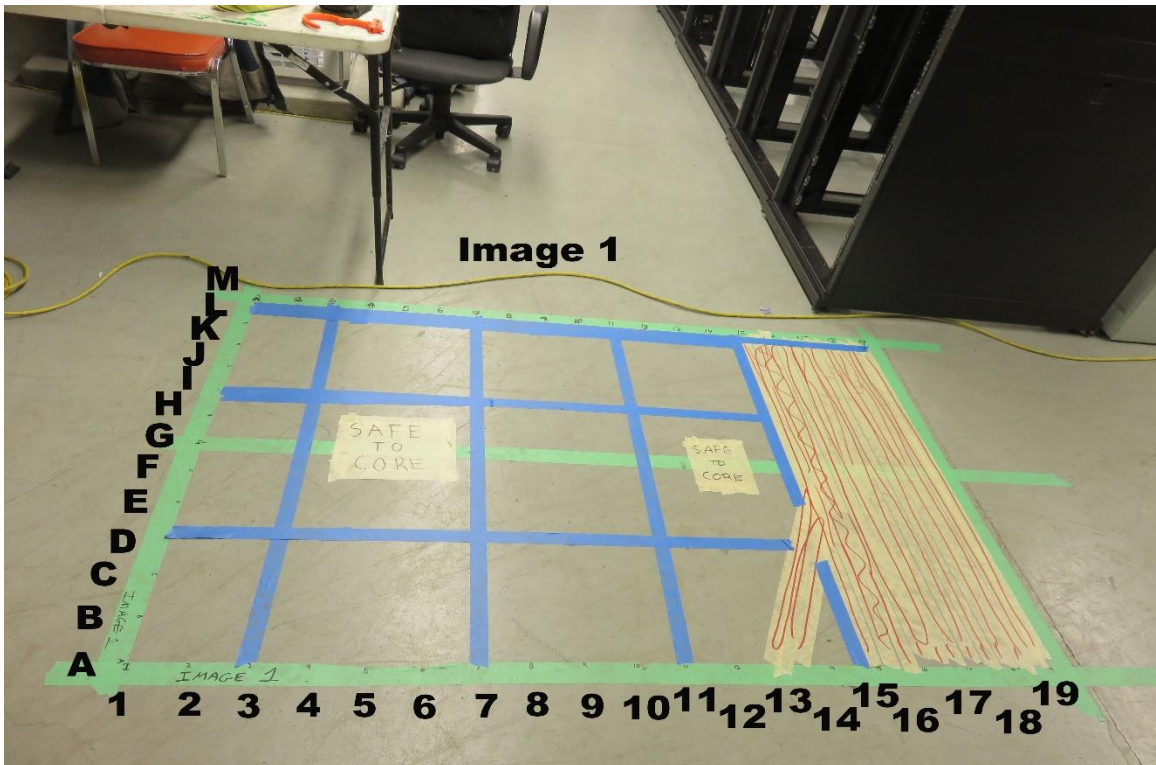
The pictures below show an overview of the location for Image 1.

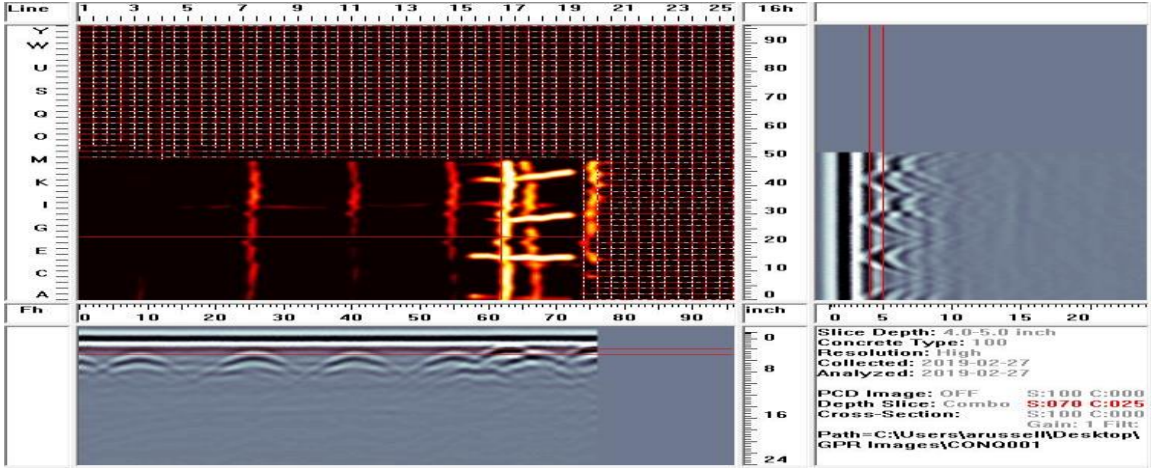
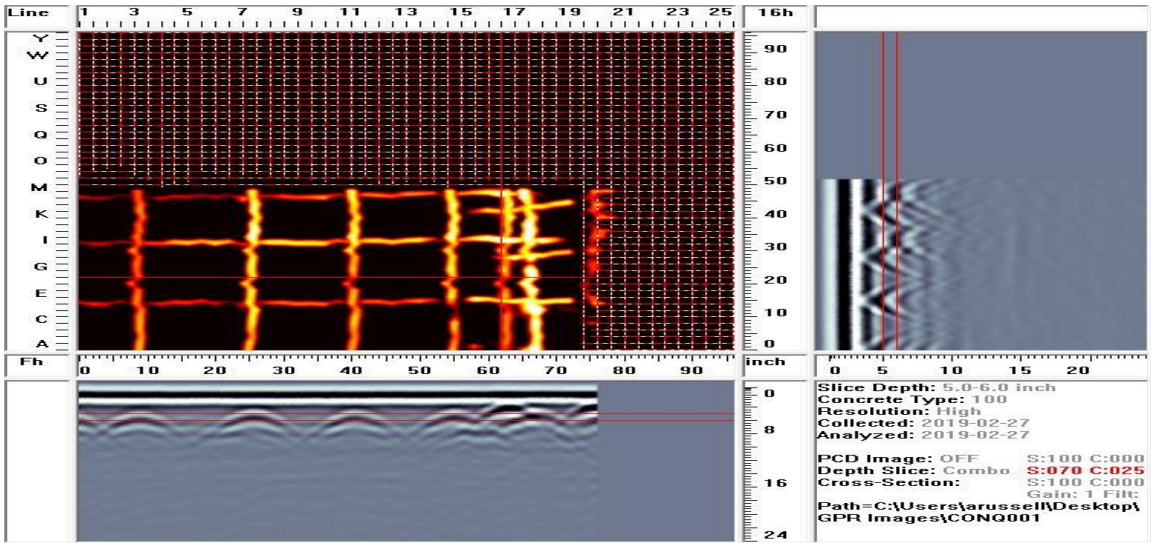
Image 1 – GPR Image (depth slice 4, 5 and 8) 4x6 foot Grid

Results: The rebar mat varies in spacing and in some areas has an upper and lower level. Power conduits were also found in the images. Any conduit or unknown features were marked out with a red paint marker. The rebar signals were marked with blue tape. We do not advise that any anchors or core holes be placed over any of the features marked out. Drill in the areas that are marked “safe to core area”. The anchor depth is 3 inches, however the analysis and marking out of features was completed to a minimum depth of 5 inches as requested.

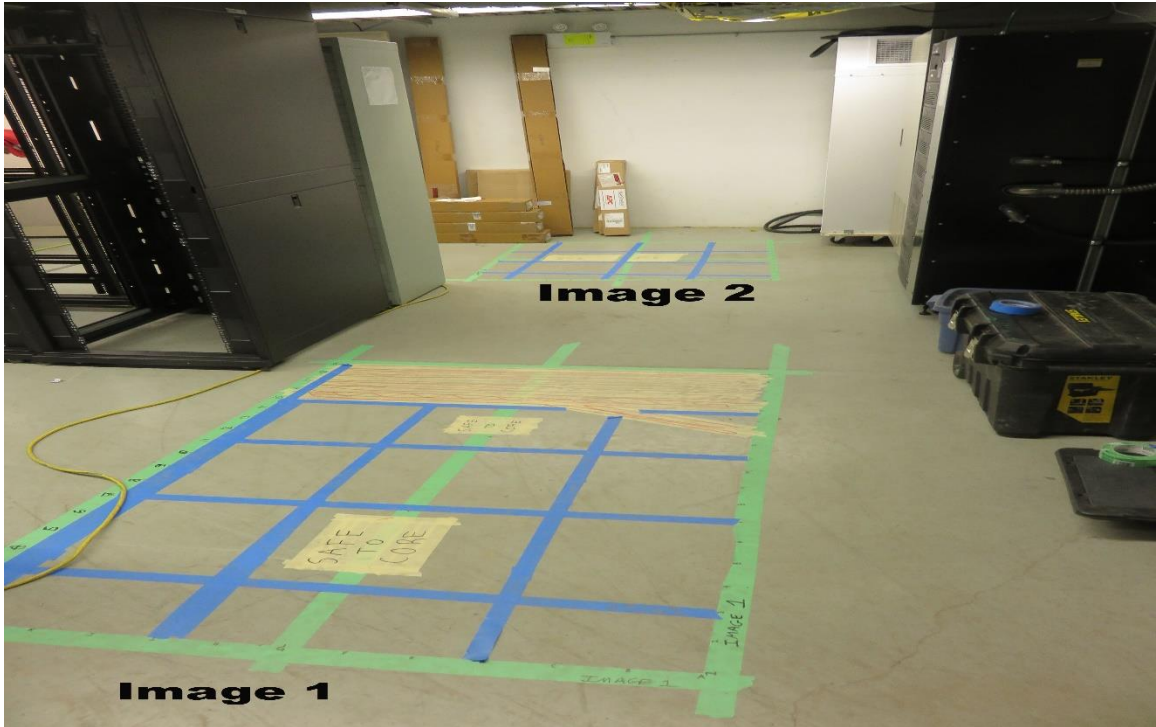
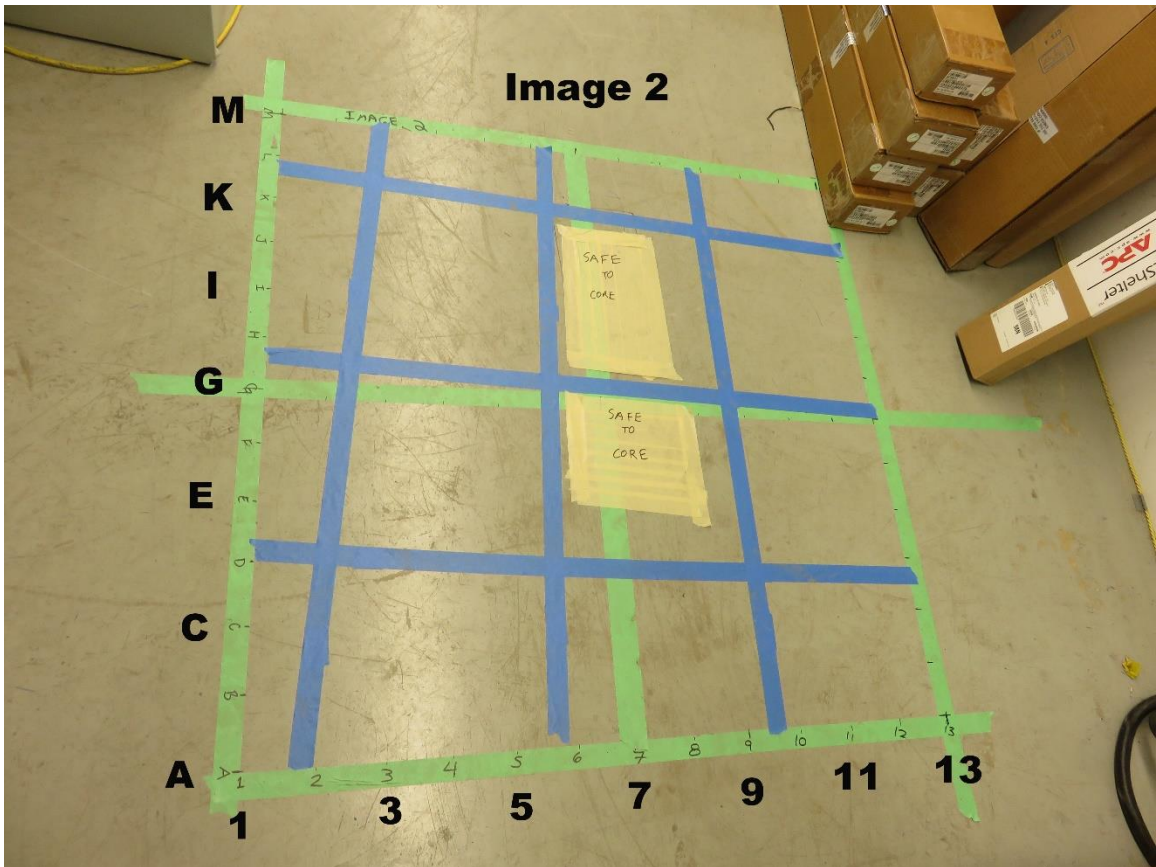
The pictures below show an overview of the location for Image 2.

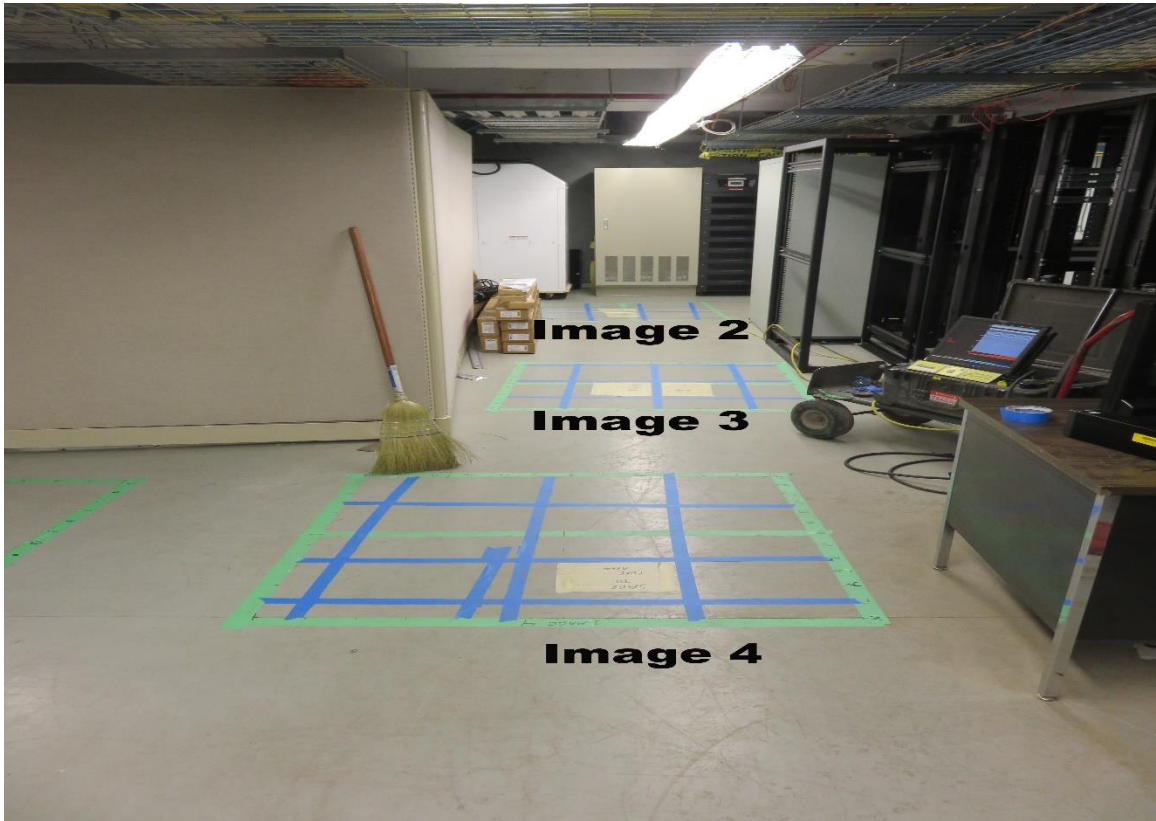
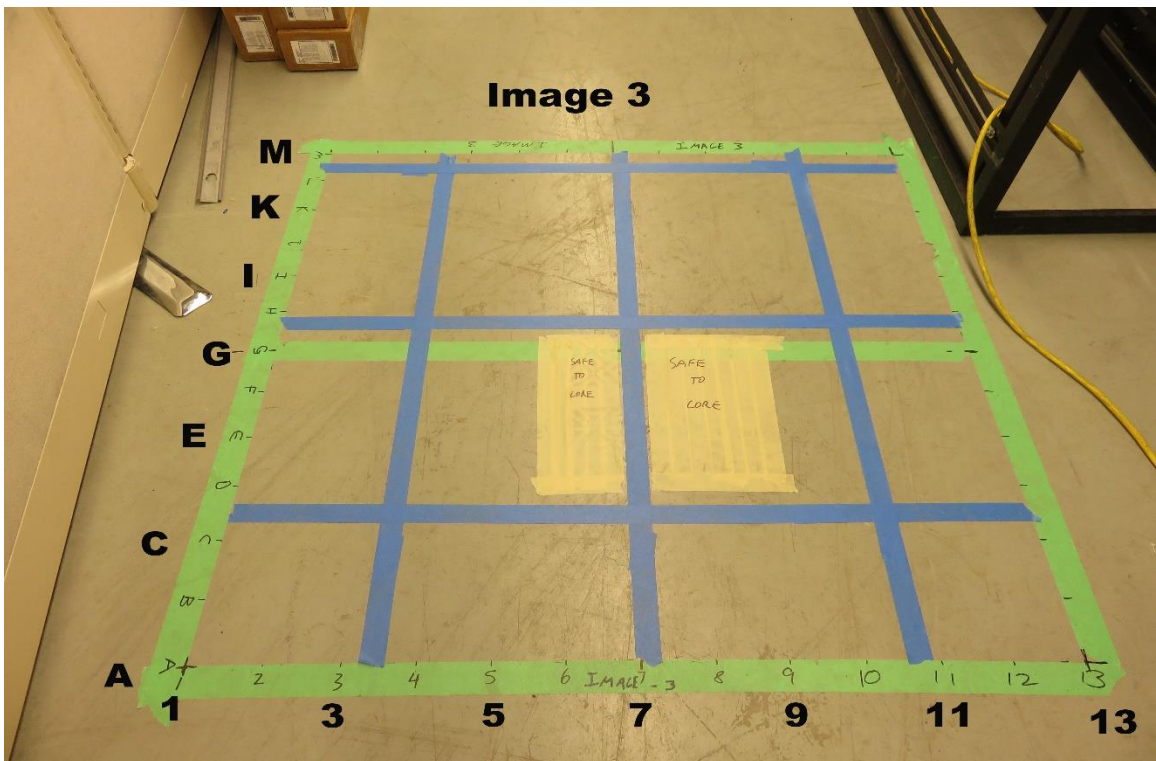
The pictures below show an overview of the locations of Image 2 to Image 4 with a closer view of Image 3.

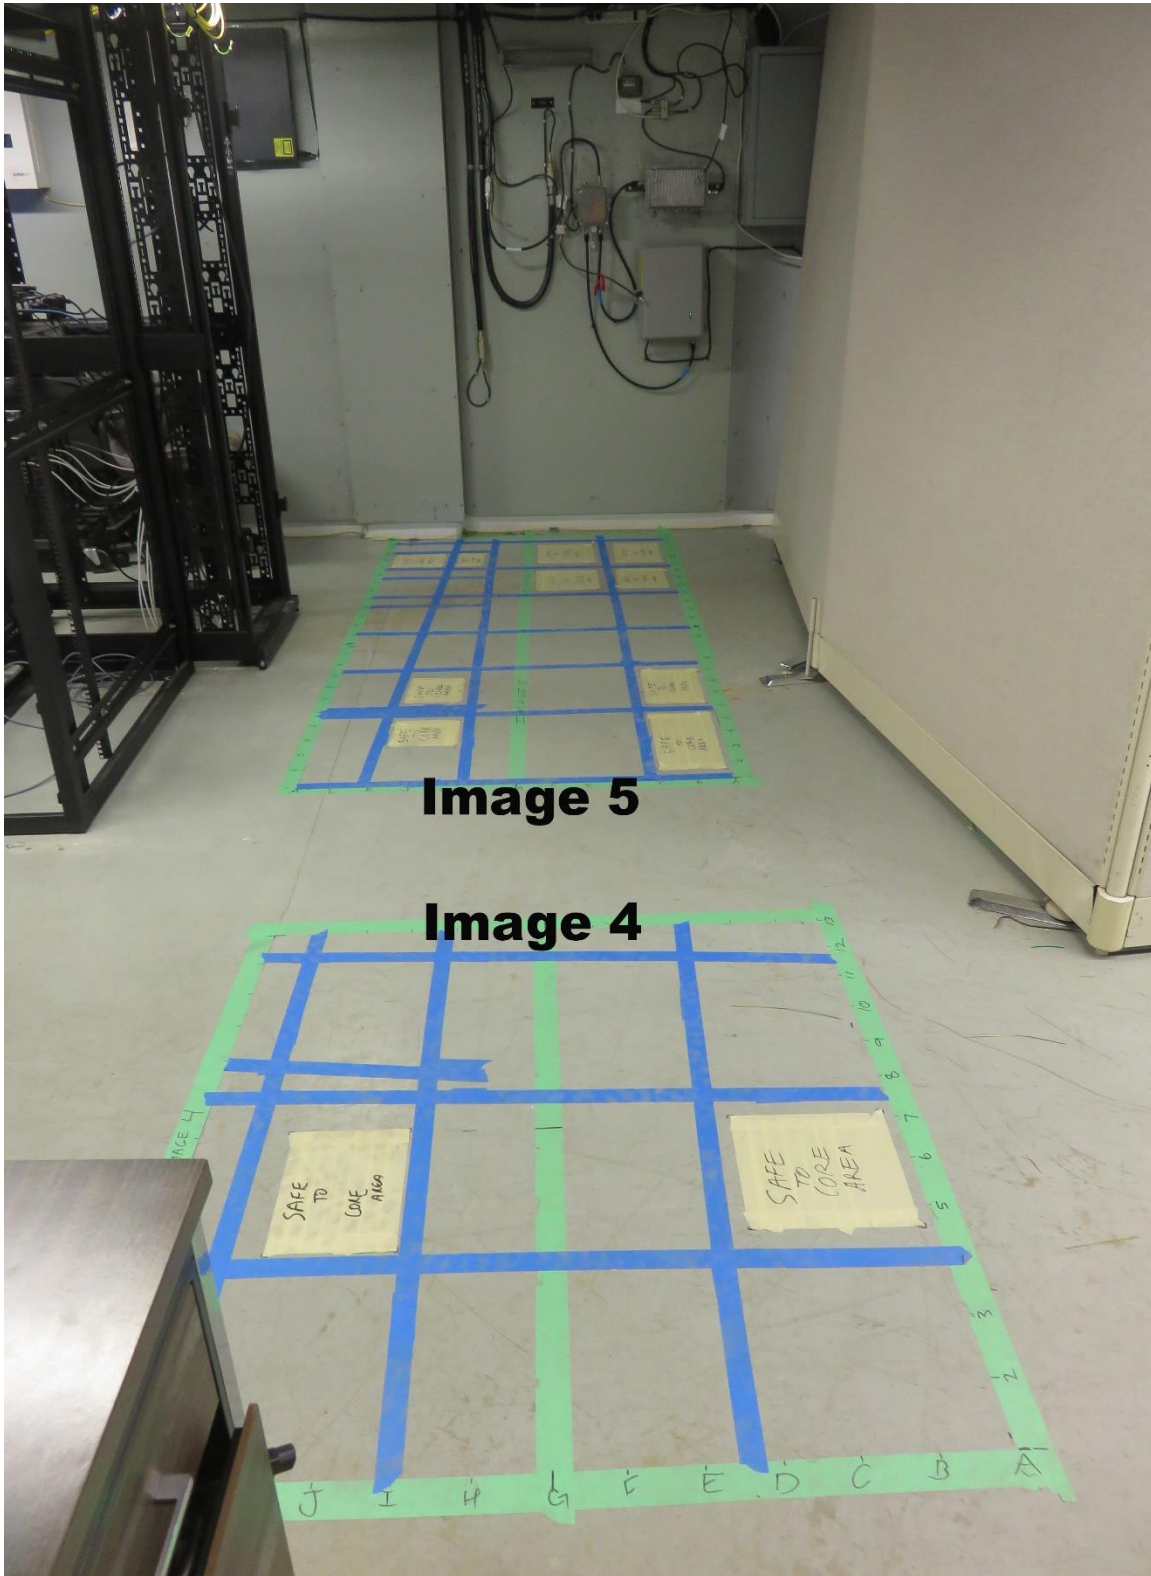
The picture below shows an overview of the location for Image 4 and Image 5.

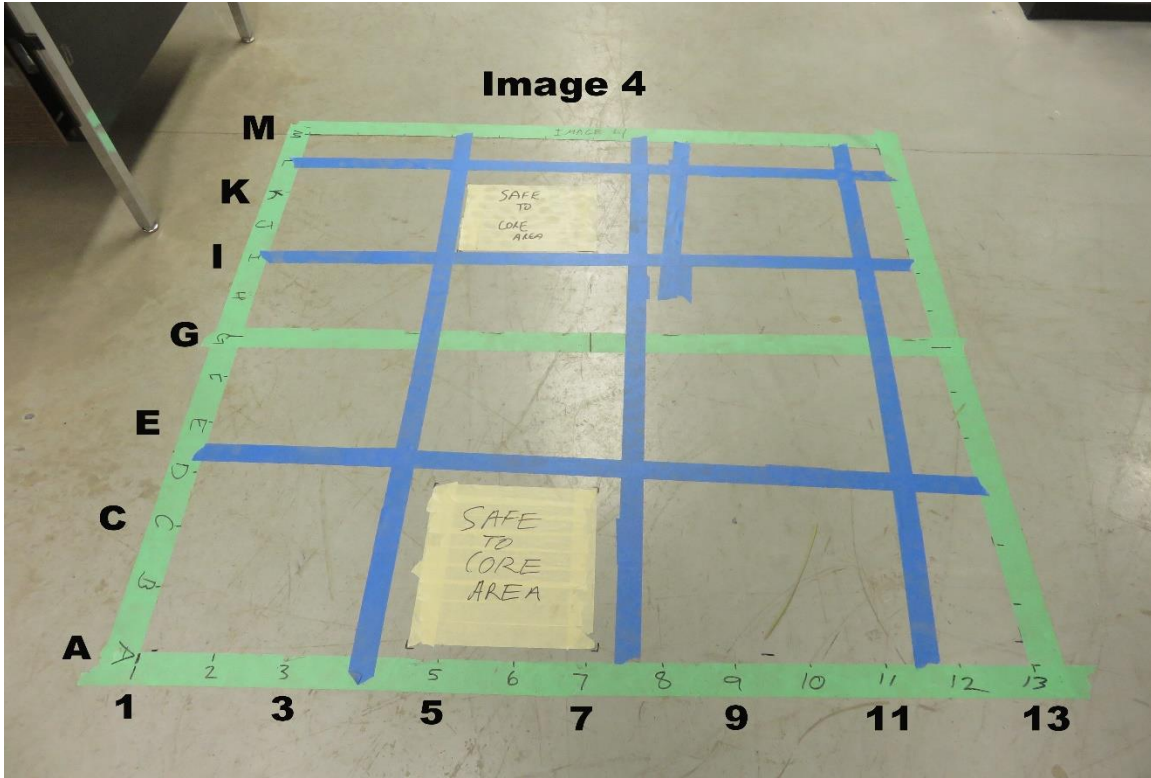
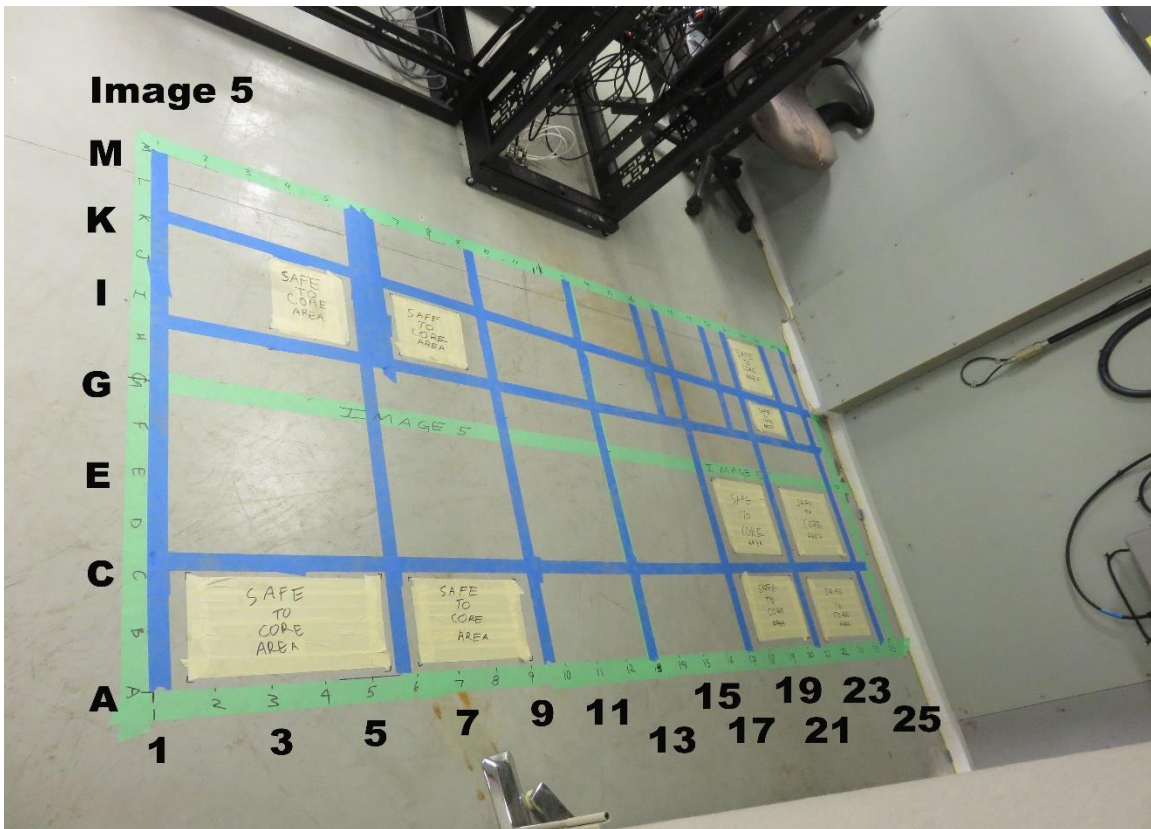
The pictures below show a closer view of Image 4 and Image 5.
