PICA

Pipeline Inspection and
Condition Analysis Corporation

8" - 72" CCTV Laser Profilometry

- Water
- Waste Water
- New Construction / Rehabilitation

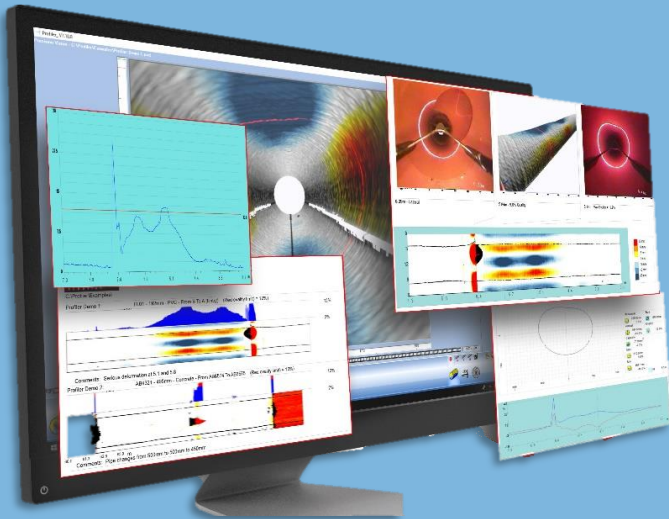
Laser pipe profiling is an essential tool for determining the accurate internal condition of a pipe. A laser profiler is a slim probe that is mounted on the front of a CCTV crawler inspection unit.

The laser projects a ring of light onto the interior of a pipe wall, as the camera moves through the pipe. Machine Vision software analyzes the laser data to build a profile of the pipe interior surface.

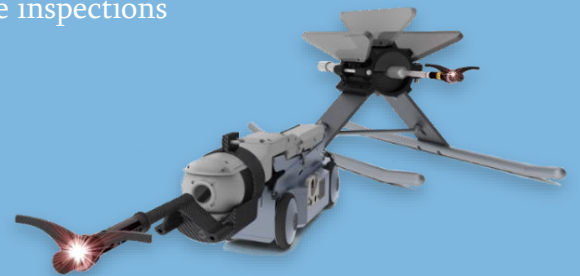
- Pipe Diameter: 8 to 72 in. (200 mm – 1830 mm)
- Over 4,000 measurements per second
- Data exports to standard modelling software
- Complete long-range inspections

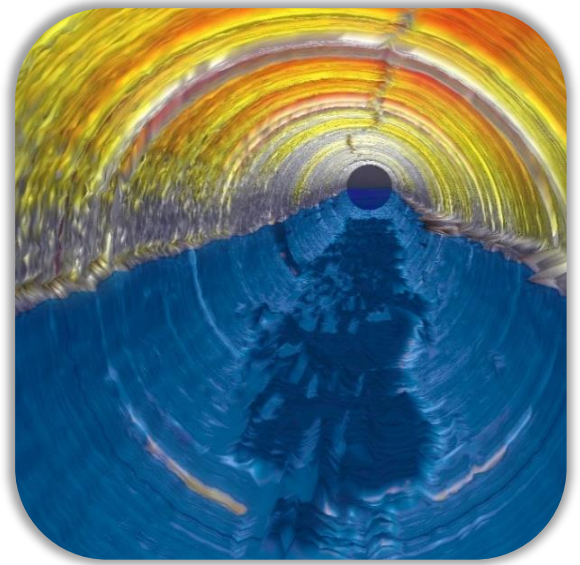
- Assess pipe ID shape and cross-sectional area
- Quantify holes, fractures and other defects
- Identify corrosion and erosion on pipe wall
- Define debris quantity and depth or water levels
- Predict best rehabilitation method
- Verify lining condition
- Confirm new capacity post rehabilitation
- Create a baseline record for new construction and future monitoring

Laser pipe profiling defines pipe ovality, capacity, diameter, and alignment. It can also identify faults, infiltration, and general deterioration in piping infrastructure.

Data collected are rendered in 2-dimensional and 3-dimensional images. Location and measurement details of any anomalies are reported. Clients can use this information to create a baseline record of new construction, and to make informed decisions regarding repair, re-lining or other rehabilitation methods for their existing infrastructure.
